THE FIRE RESISTANCE OF PRESTRESSED CONCRETE BEAMS

NBS PROJECT		NBS REPORT
1002-30-4822	June 1, 1954	3368

Bureau of Yards and Docks
Department of the Navy
Project Order No. 61705

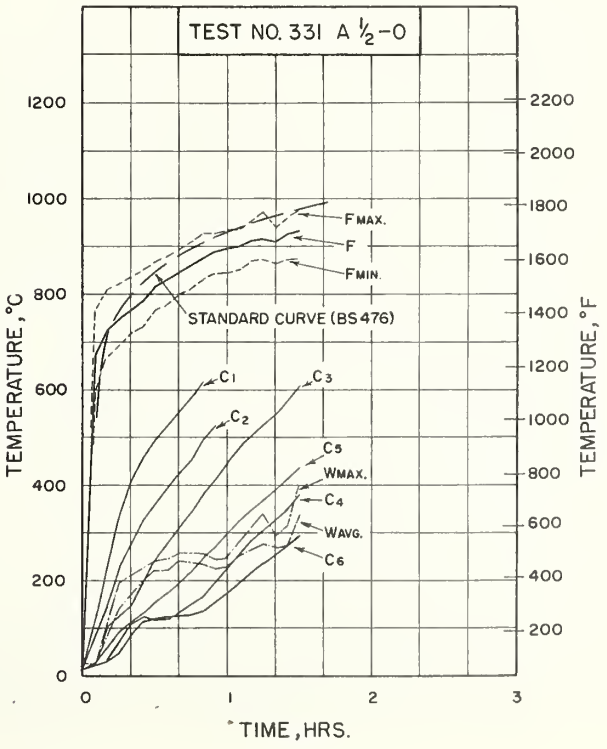
FIG. 5 TEMPERATURES OBSERVED DURING TEST 331

The temperatures indicated by the steel cable thermocouples changed rather erratically during the test. However, the furnace temperature control was fairly good, and the temperatures at the various locations in the beam rose in smooth curves, as shown in figure 5.

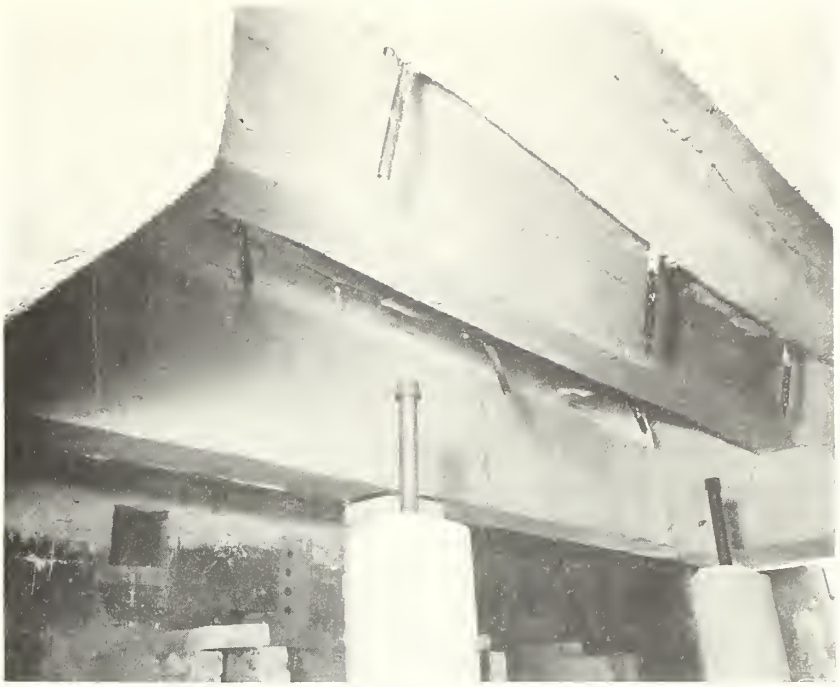
The day after the test, the beam had recovered some of the deflection and a reloading test was made. The beam failed under a load of 10.4 long tons, almost the same as the test load. Following the reloading test, when the specimen was broken up, it was found that all of the wires in the prestressed cable were unbroken but the steel-constantan junctions were rusty, possibly accounting for the observed variations in cable temperatures. The conditions of the beam after the fire test and after the reloading test are shown in figures 6 and 7.

FIG. 6 A-1/2-0 BEAM AFTER FIRE TEST 331

FIG. 7 A-1/2-0 BEAM AFTER FIRE TEST 331 AND RELOADING TEST

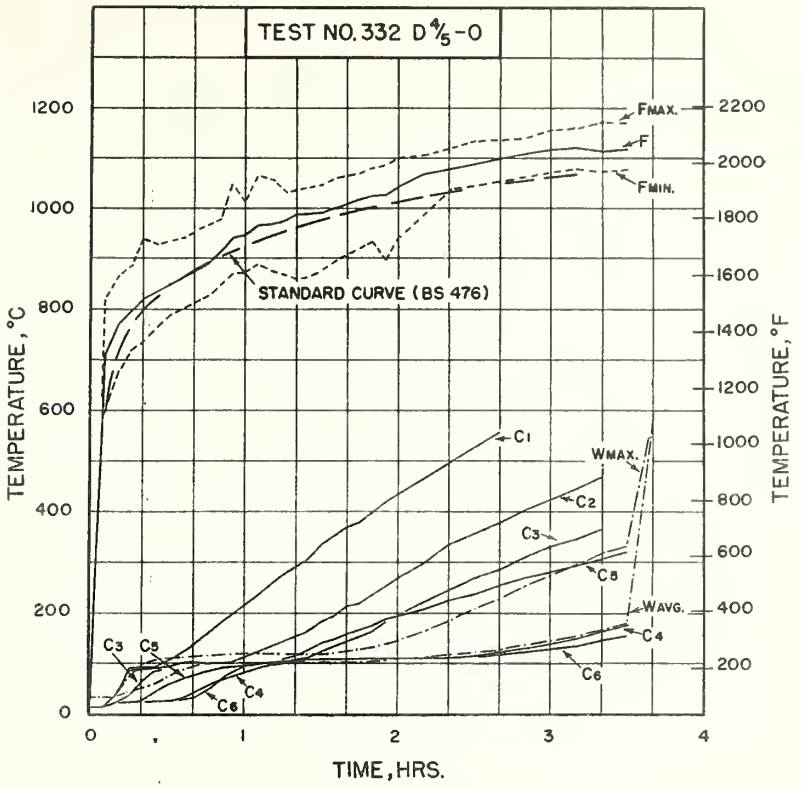
FIG. 8 TEMPERATURES OBSERVED DURING TEST 332. TEST STOPPED BEFORE ALL 3 HR. 40 MIN. TEMPERATURE OBSERVATIONS COMPLETED

The furnace control was fairly good, the average temperature having been near or slightly above the Standard curve throughout the test. The temperatures at the various locations in the beam rose to about 212° F (100°C) and leveled off for periods ranging from 10 min to 1 hr 10 min before continuing upward, apparently indicating time required to eliminate moisture. The cable temperatures behaved in a similar manner but remained near 212° F about 1 3/4 hr. The temperature curves are shown in figure 8.

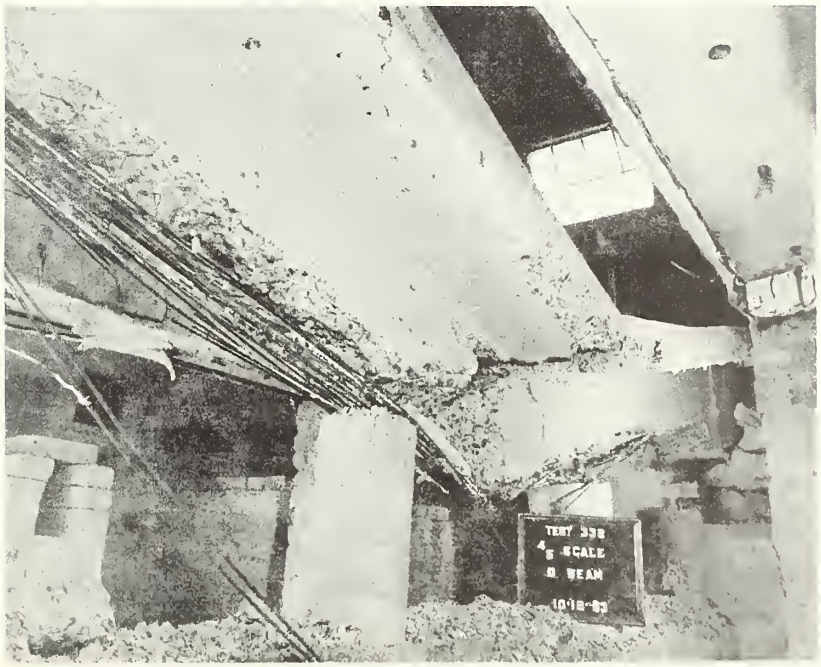
FIG. 9, D·4/5·0 BEAM AFTER FIRE TEST 332, SHOWING BREAKS IN SLAB, BEAM, AND CABLE, THE LATTER GROUPED IN TWO LOCATIONS.

After the test, the beam and slab were found to have broken in the middle, and the bottom concrete had broken off to expose the prestressed wires from haunch to haunch. The breaks in the broken wires were not all in one location but were divided into two locations, as shown in figure 9. All the wires were broken.

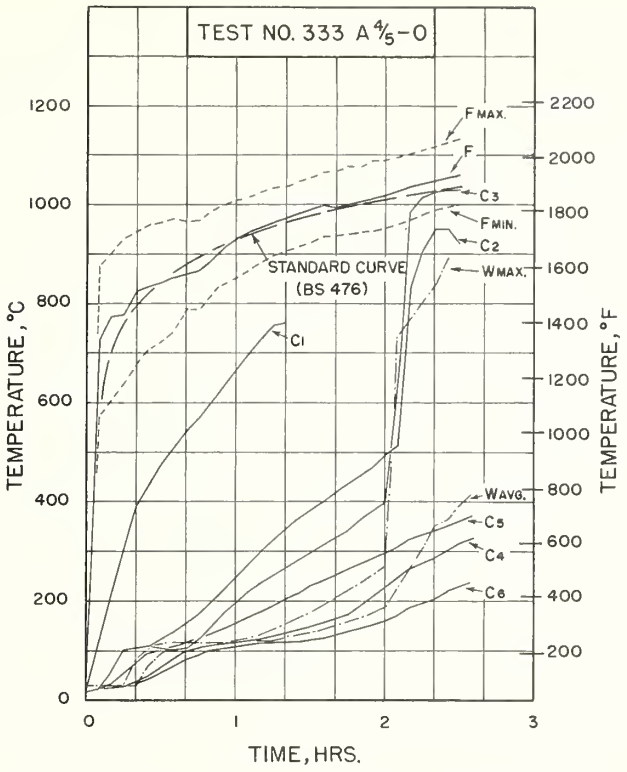
FIG. 10 TEMPERATURES OBSERVED DURING TEST 333

The furnace control was good, the average temperature having been near that specified in the Standard Time-Temperature Curve throughout the test. The temperatures indicated by the six thermocouples in the concrete rose smoothly during the first 2 hr but those by two jumped quickly thereafter. The temperatures in the prestressed cable behaved in a similar manner, as shown in figure 10.

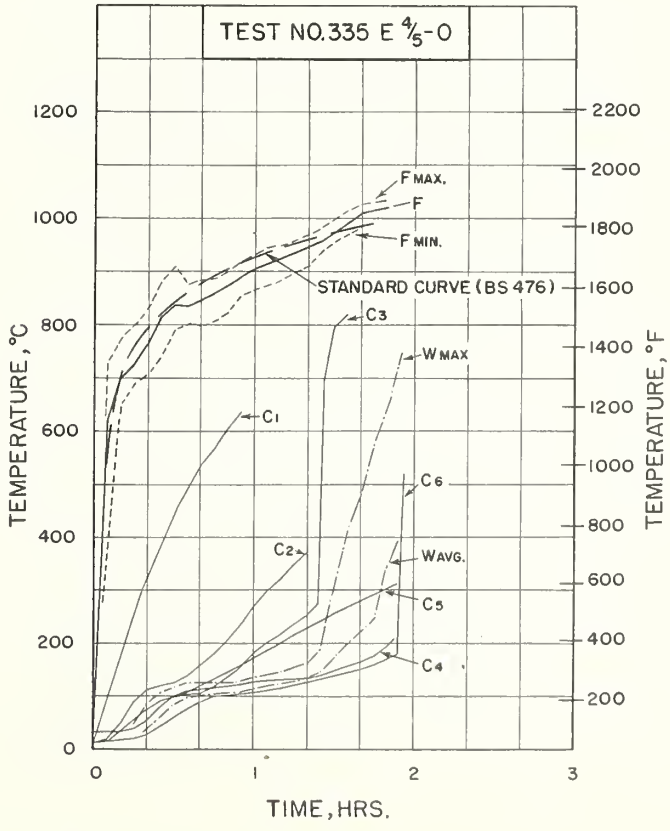
FIG. 17 TEMPERATURES OBSERVED DURING TEST 335

The furnace control was fairly good, the average temperature being a little low during most of the test. The temperatures in the concrete and cable rose smoothly at first but jumped after 1 1/2 hr as shown in figure 17, probably due to cracking. Three of the thermocouples in the concrete became inoperative before the end of the test.

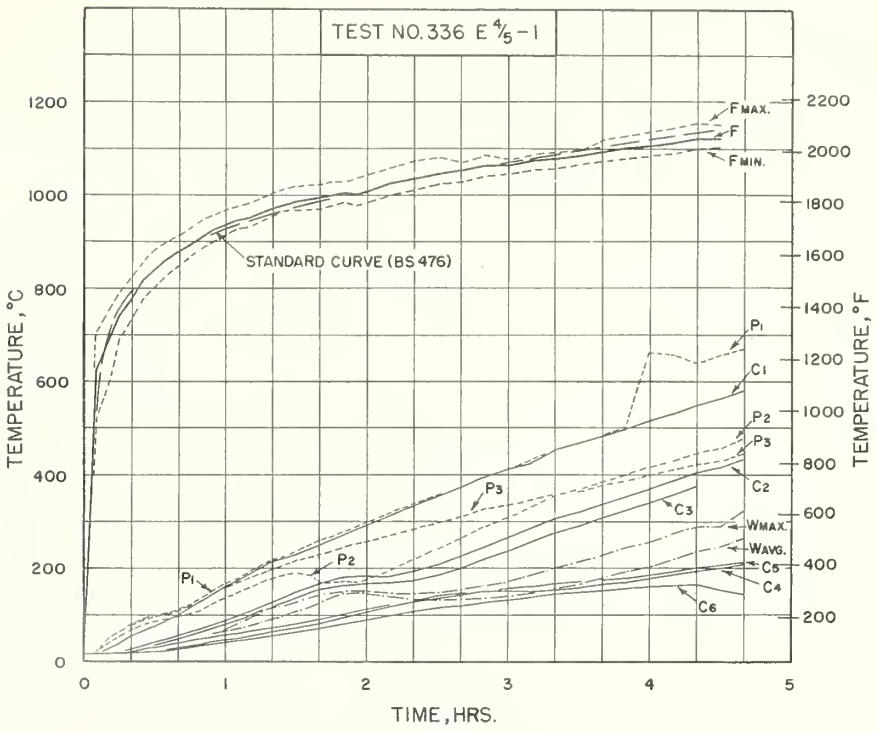
FIG. 18 TEMPERATURES OBSERVED DURING TEST 336

The furnace control was good, the average temperature having been very near that specified by the Standard Time-Temperature Curve throughout the test. The temperatures in the concrete and cable rose smoothly and gradually, except that indicated by thermocouple P_1 which jumped at about 4 hr, as shown in figure 18.

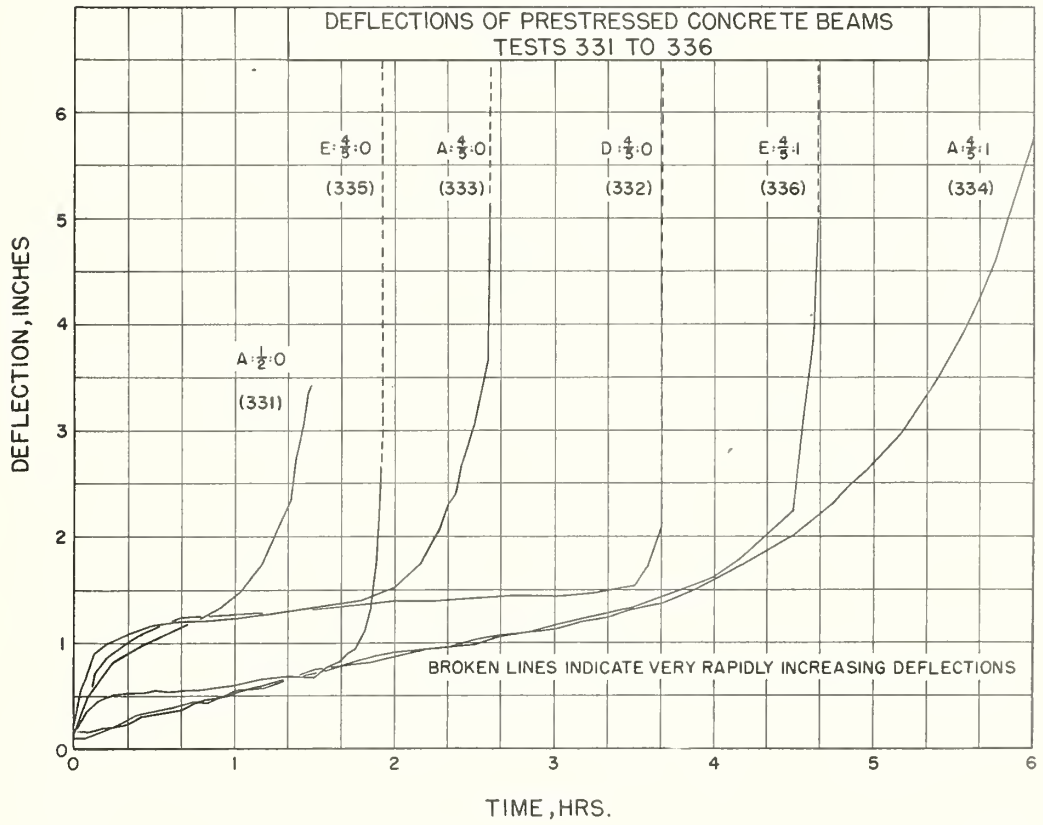
FIG. 20 DEFLECTIONS AT CENTERS OF BEAMS OBSERVED DURING TESTS, ALL DEFLECTIONS DOWNWARD

The curves of deflections versus time in figure 20 show large early deflections followed by a steady state period for the unprotected beams, but a slow more or less uniform increase of deflection for the insulated beams. This effect is believed to be one of differential thermal expansion. As the concrete at the beam soffit, and the bottom of the slab of an A or D beam, is heated rapidly at the start of the fire exposure it expands while the concrete in the interior of the beam and the top of the slab remains cool and does not expand. In these beams of high strength concrete, a bowing toward the hot surface resulted. For the E:4/5:0
